U.S. 301 PROJECT DEVELOPMENT

DETERMINATION OF ELIGIBILITY REPORT

Volume IV

Volume IV: Narratives and CRS Forms for N14358 to N14397

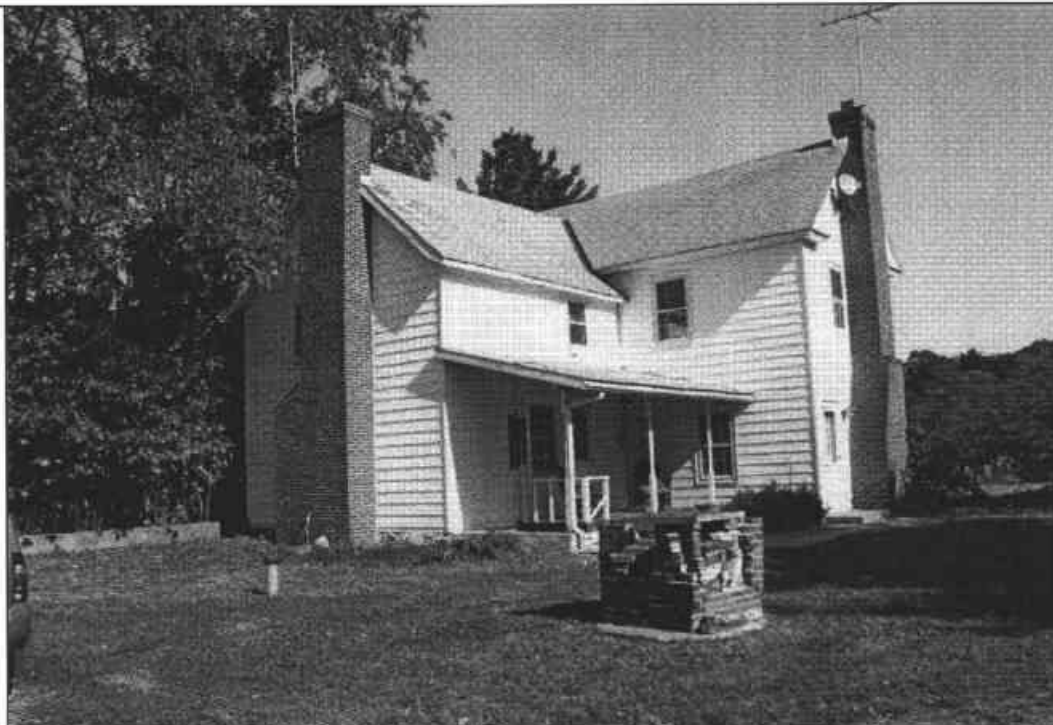
N14379. Photograph 1: Dwelling, west and south elevations, view to northeast.

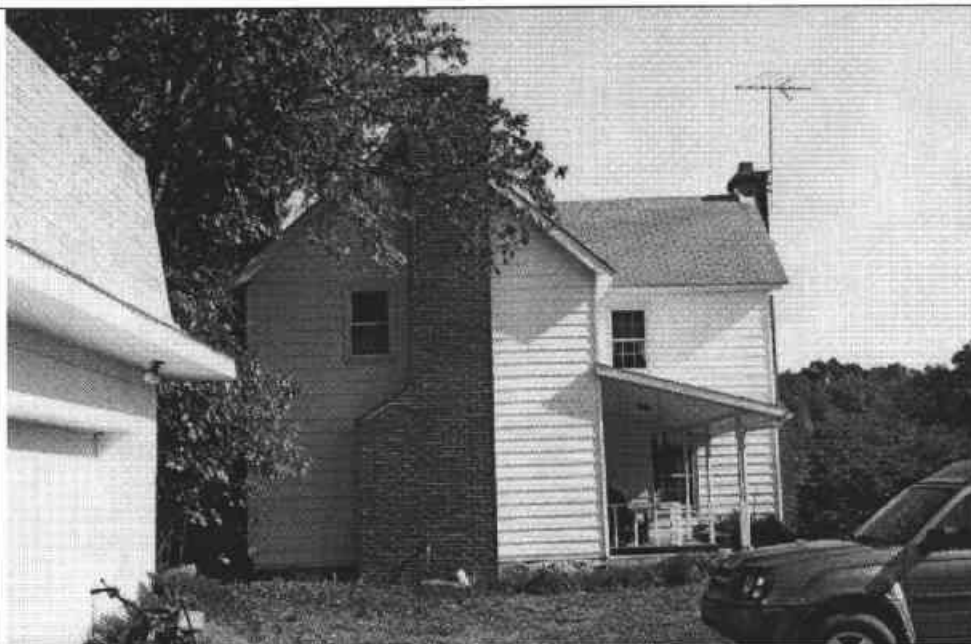
N14379. Photograph 2: Dwelling, west elevation, view to east. Note the exterior brick chimney on the west elevation of the rear ell, which was erected by the current owner ca. 1965.

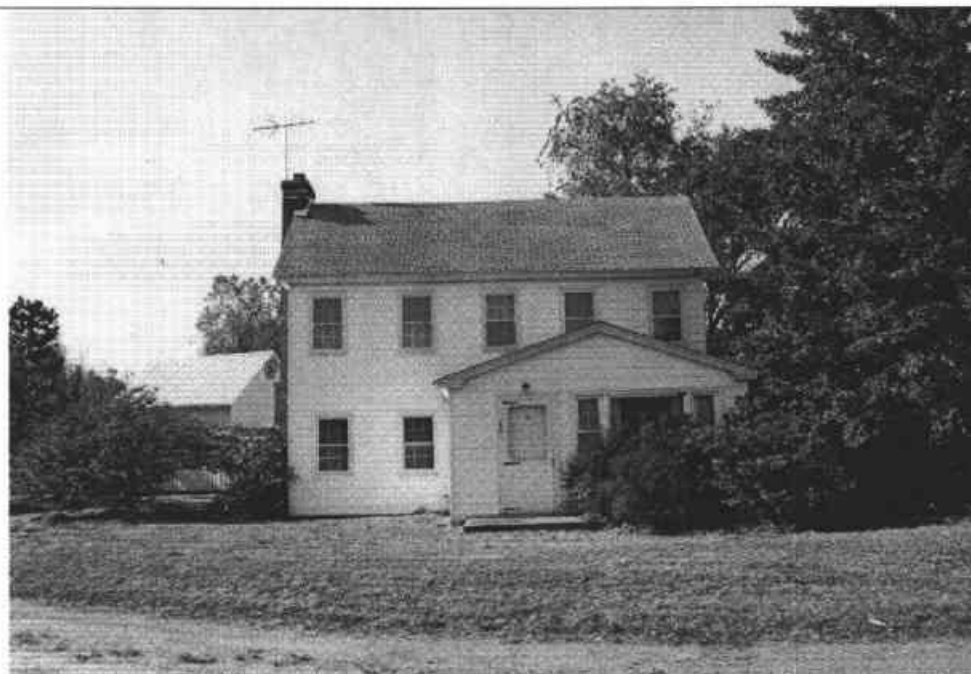
N14379. Photograph 3: Dwelling, east elevation, view to west. Note the one-story gable front addition with Chicago window that extends from the eastern elevation.

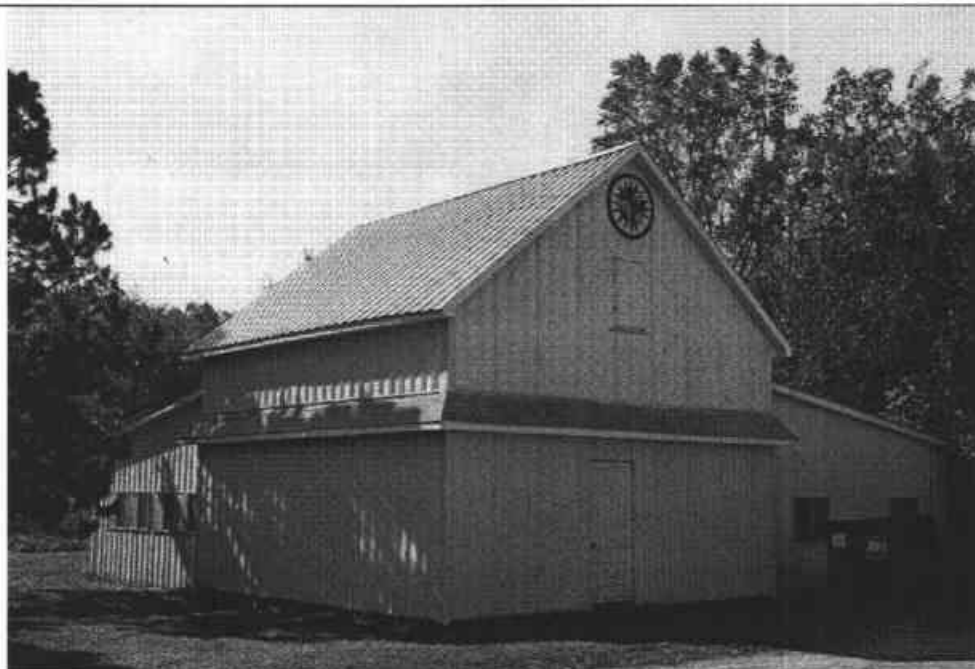
N14379. Photograph 4: Granary, east and north elevations, view to southwest. Note vertical metal siding and the additions extending from the south and west elevations.

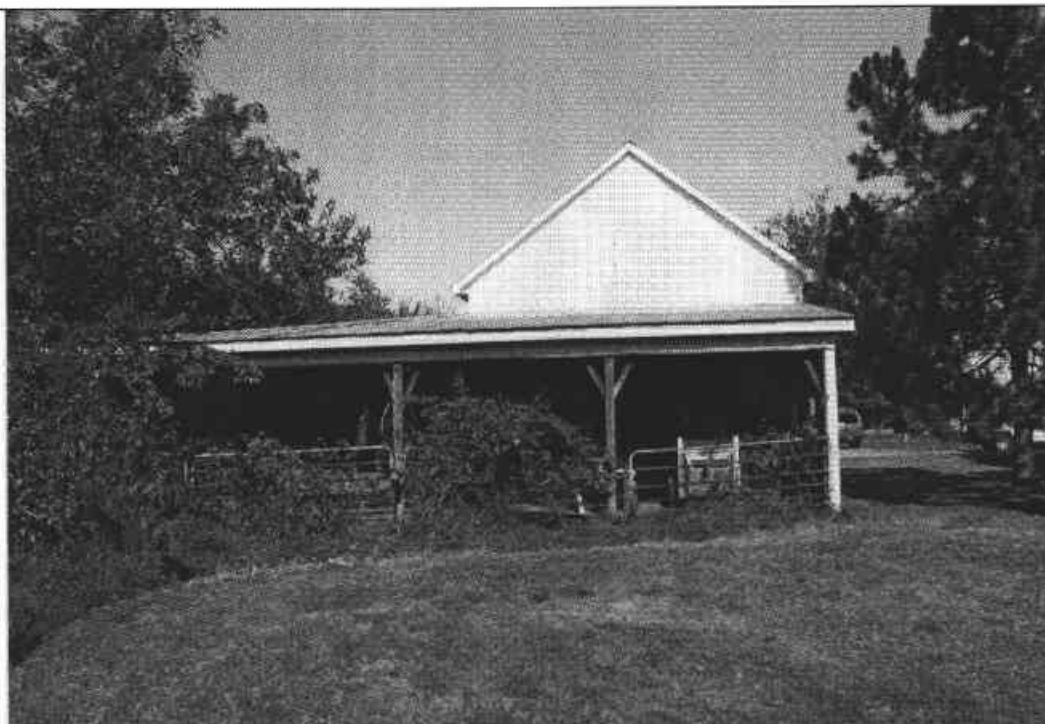
N14379. Photograph 5: Granary, south elevation, view to north. Note the lean-to addition with open bays.

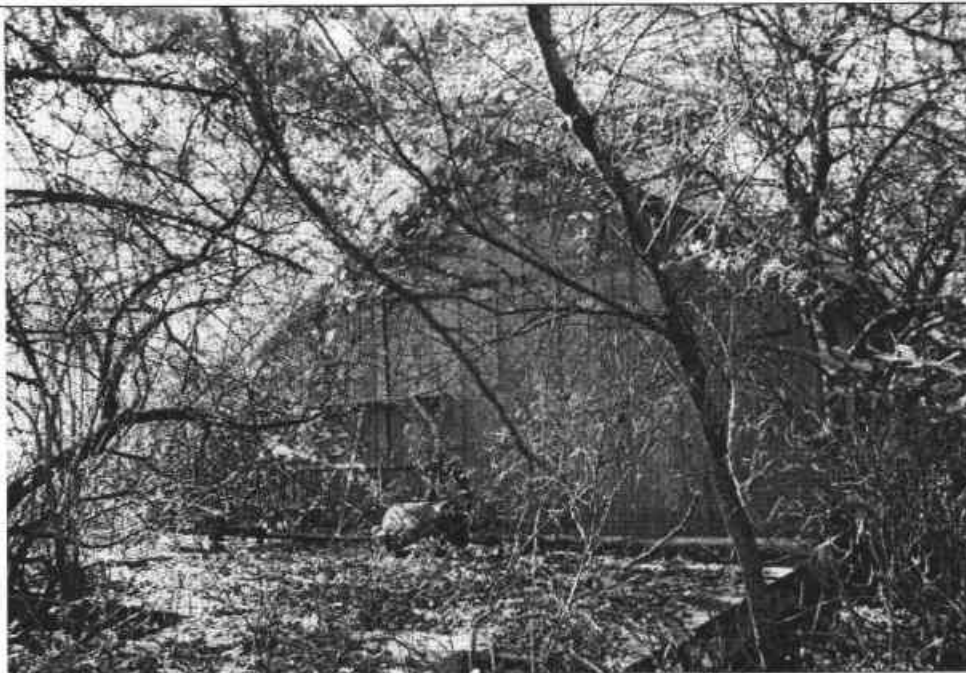
N14379. Photograph 6: Former chicken coop, northeast elevation, view to southwest.

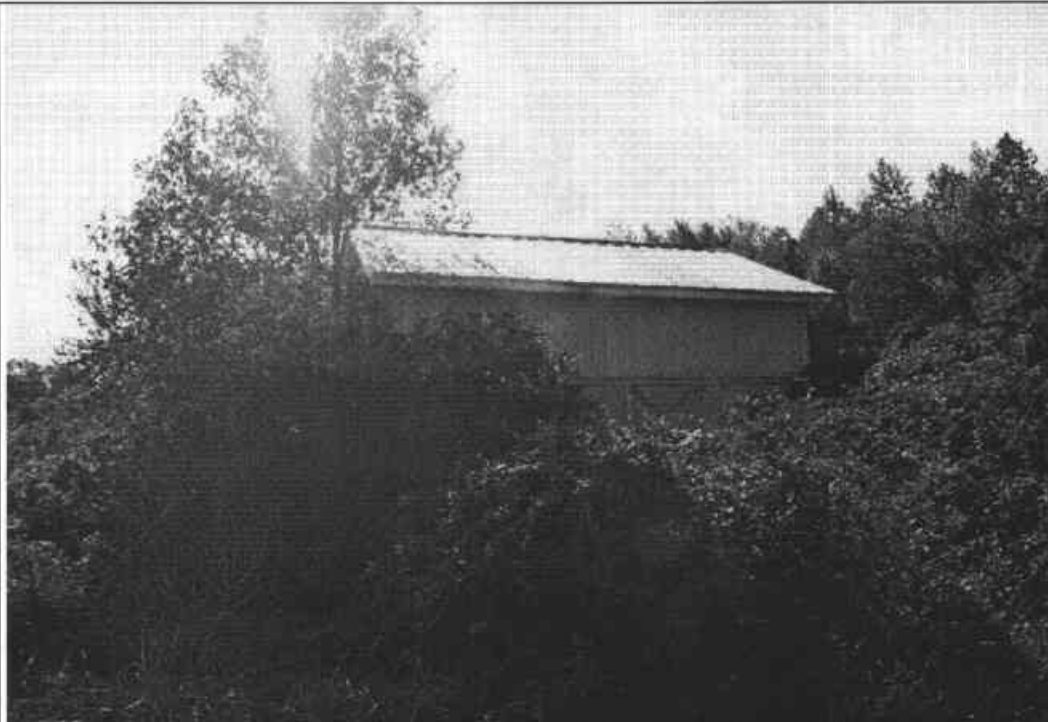
N14379. Photograph 7: Outbuilding for goats, north elevation, view to south. Note the mature trees and overgrown vegetation surrounding the outbuilding.

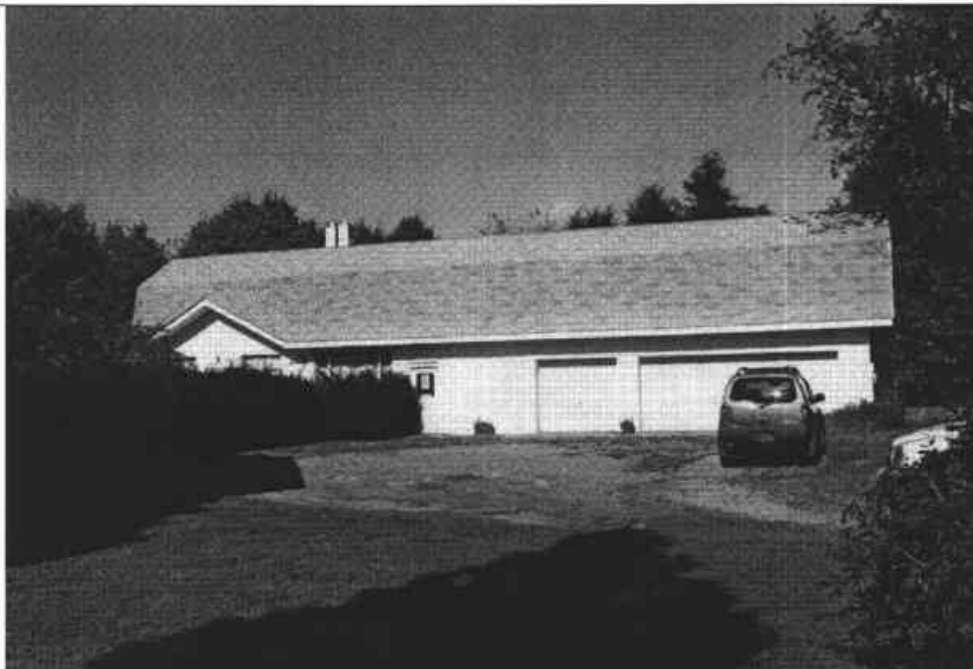
N14379. Photograph 8: Kennel/garage, south elevation, view to north.

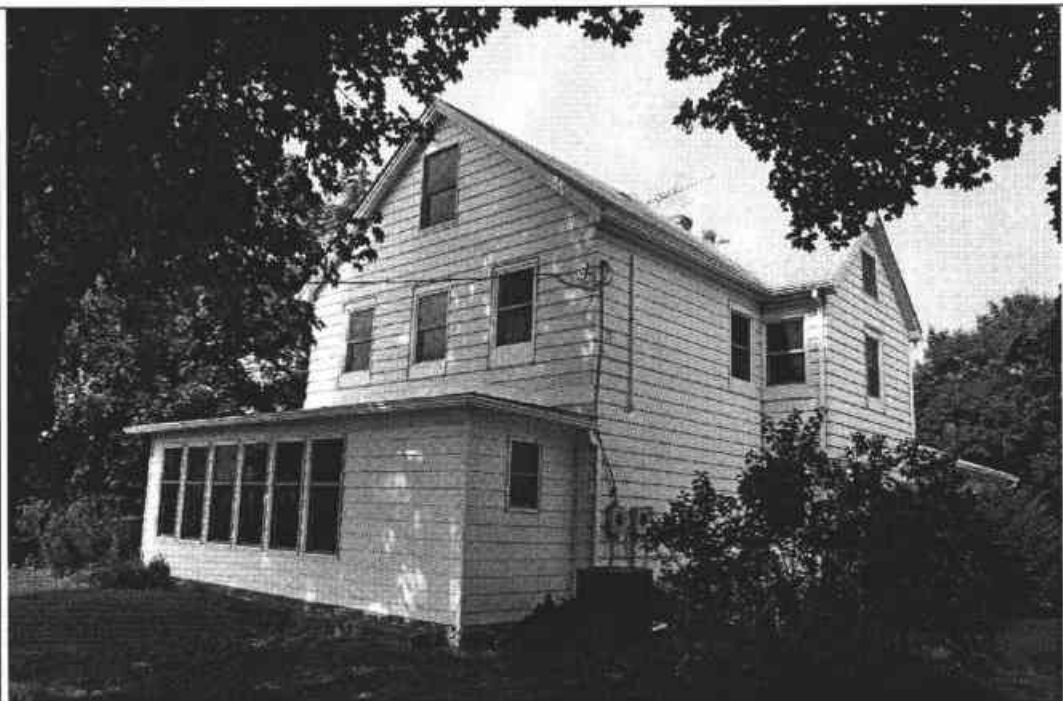
N14380. Photograph 1: Dwelling, east and north elevations, view to southwest. Note the replacement windows with faux lights, original fenestration openings, enclosed porch, and replacement cladding (aluminum).

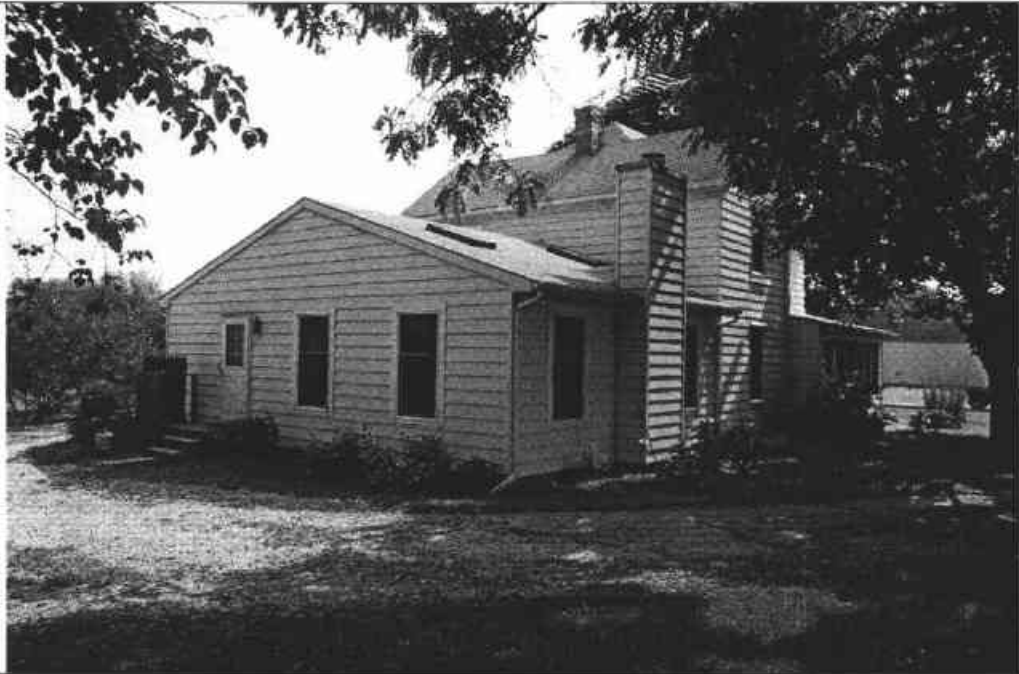
N14380. Photograph 2: Dwelling, west and south elevations, view to northeast. Note the *circa*-1990 addition extending from the core.

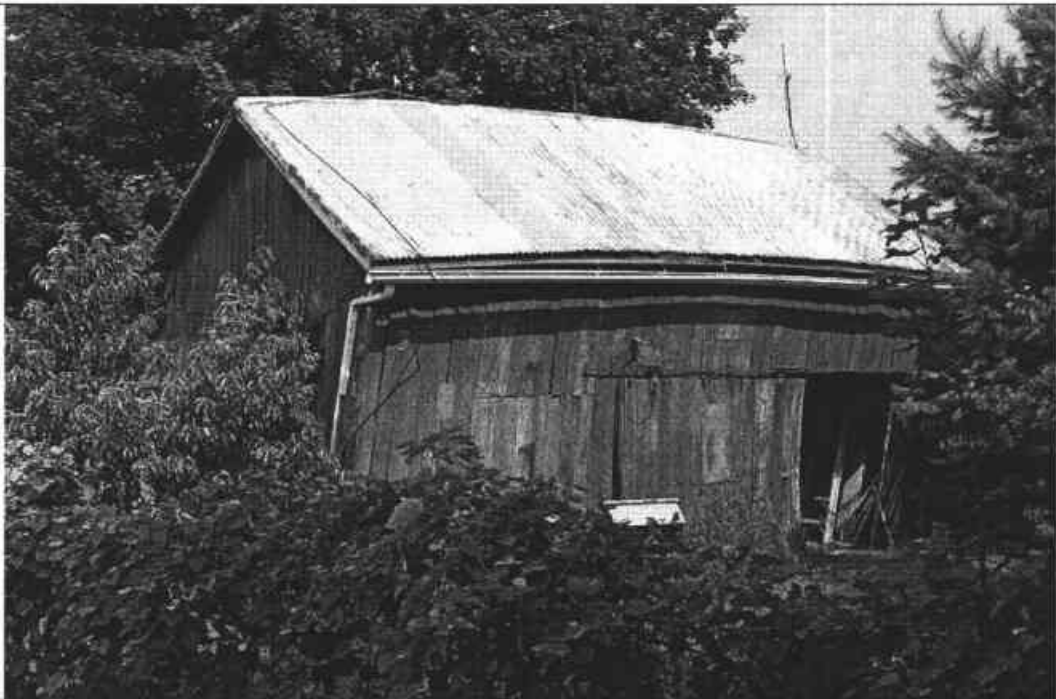
N14380. Photograph 3: Barn, east and south elevations, view to northwest. Note the sliding batten doors and the barn's poor condition. The north and west elevations were not accessible.

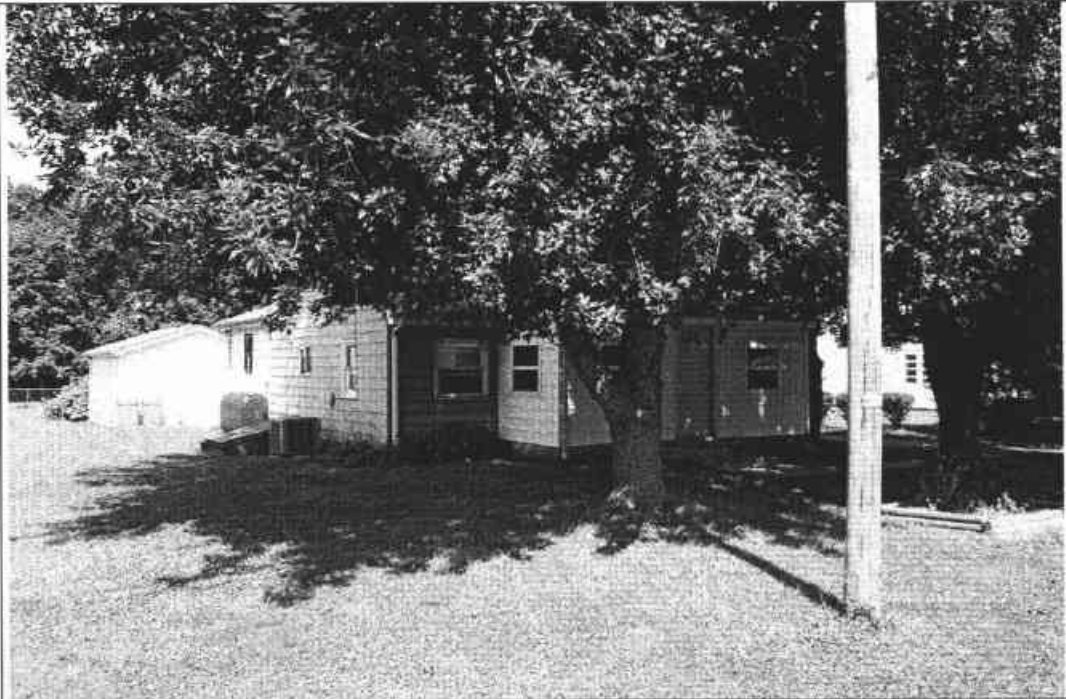
N14381. Photograph 1: Dwelling, south and east elevations, view to northwest. Note the multiple additions, modern cladding, and replacement windows and doors.

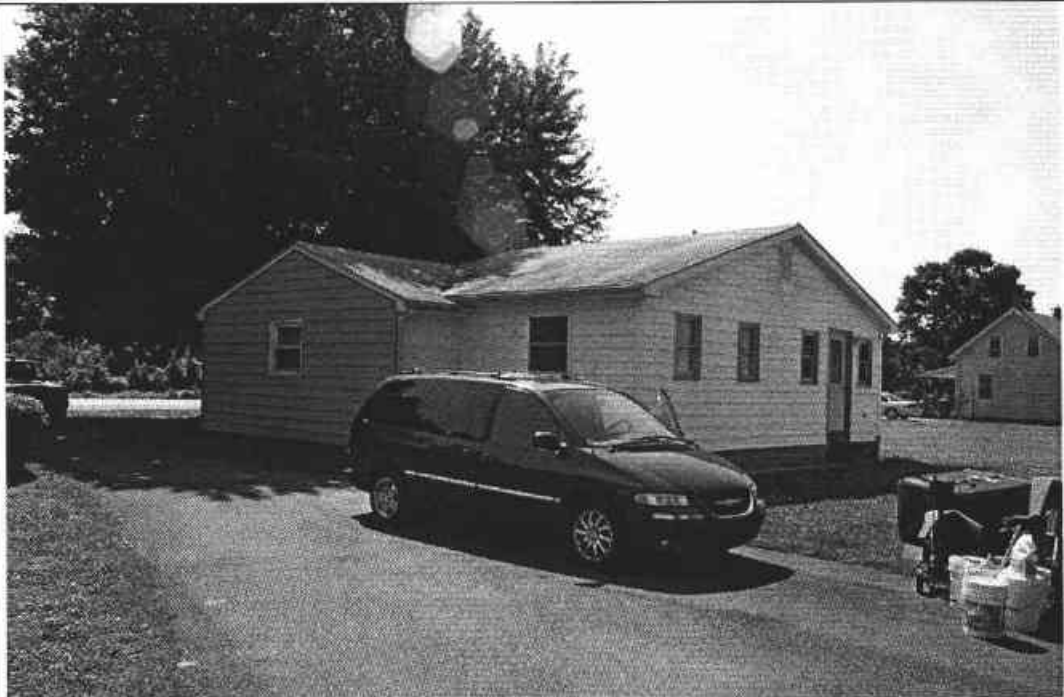
N14381. Photograph 2: Dwelling, north and west elevations, view to southeast. Note the scale of the rear addition as compared to the historic core.

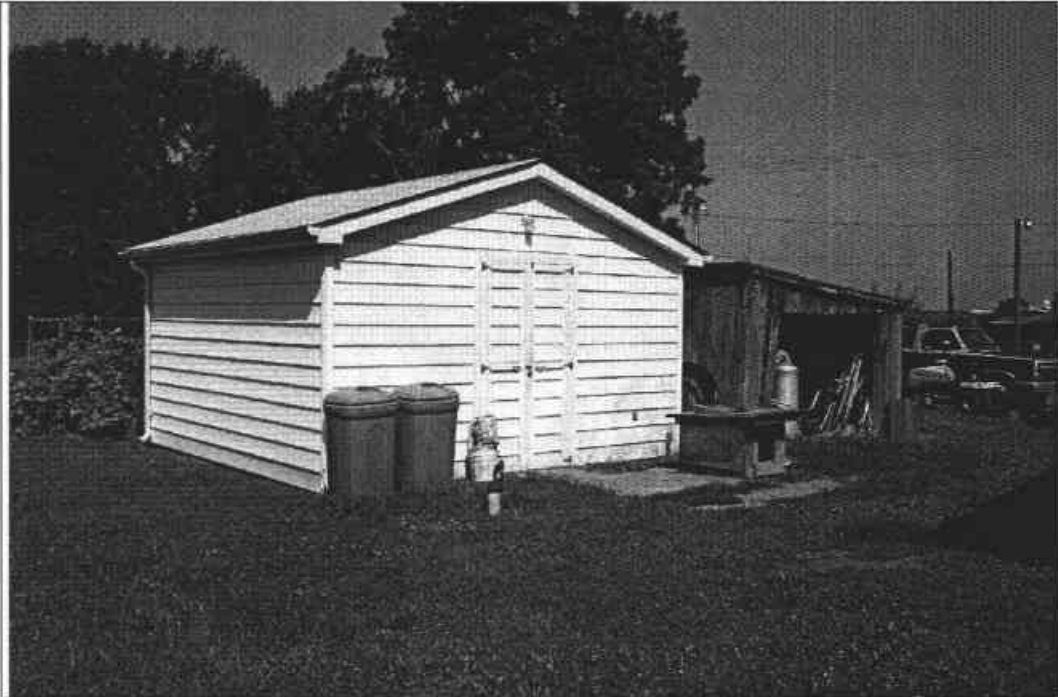
N14381. Photograph 3: Post-1962 garage and shed, view to northwest.

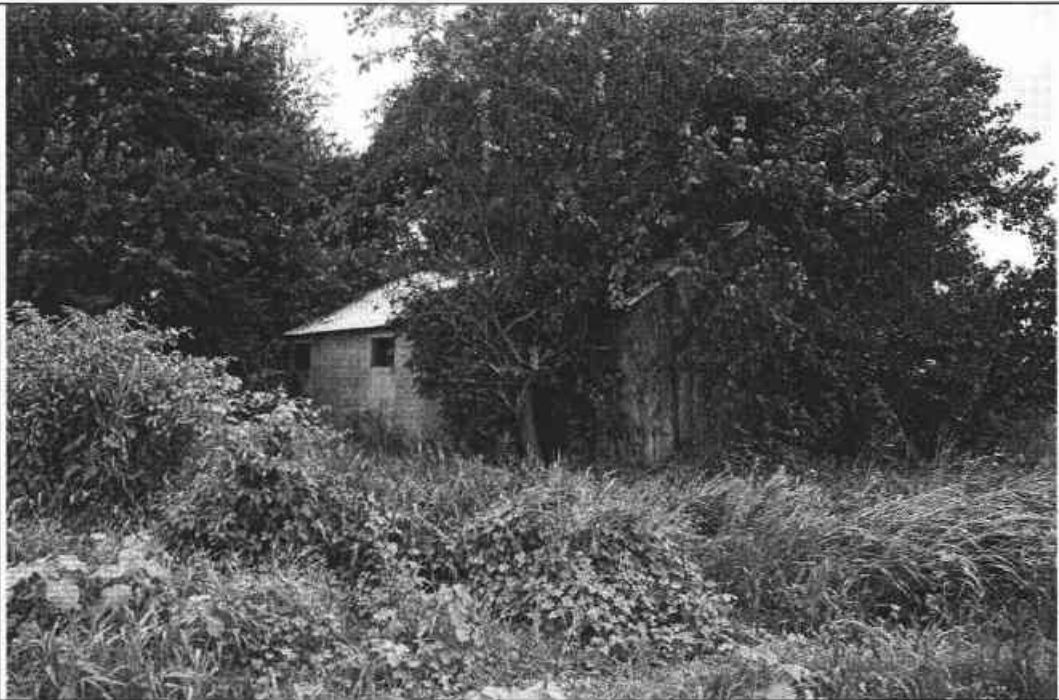
N14382. Photograph 1: Structure, north and west elevations, view looking southeast. This tenant house is located in the middle of a large agricultural field. The dwelling is abandoned and has fallen into disrepair.

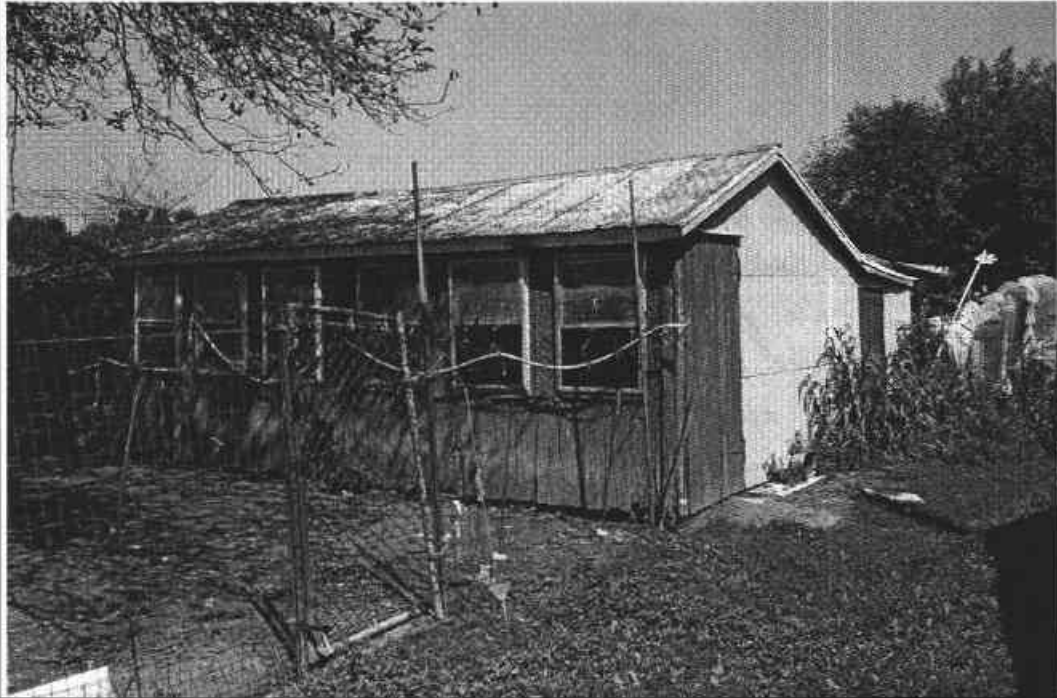
N14385. Photograph 1. Chicken House at 657 Boyds Corner Road, looking northwest, showing south and east elevations. Note asbestos panels on exterior.

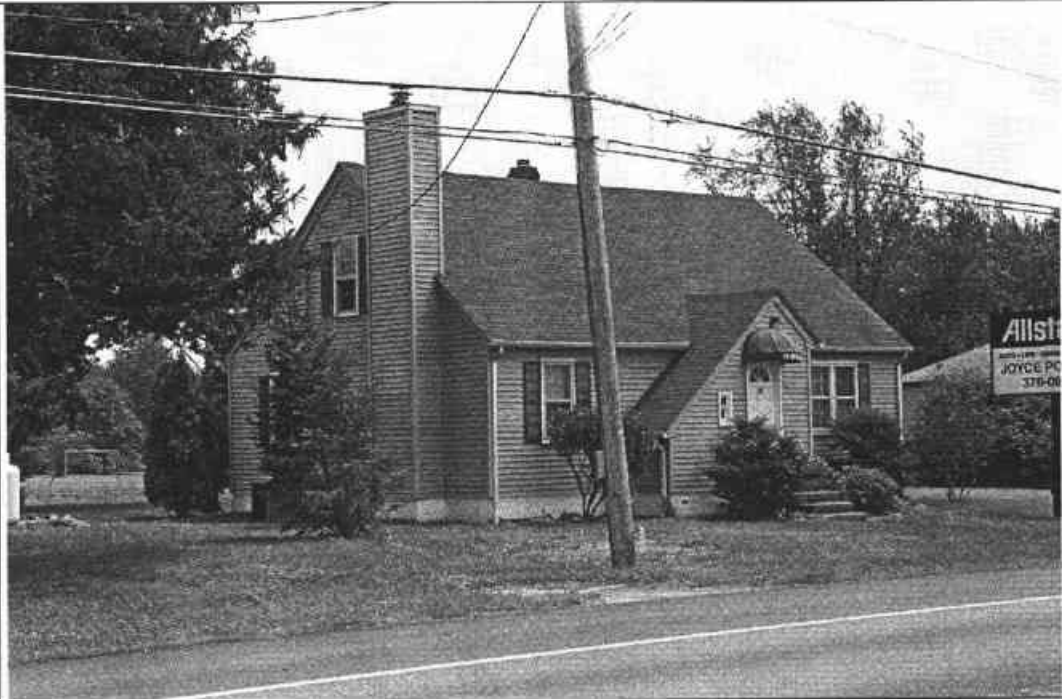
N14386. Photograph 1. 4847 Summit Bridge Road, overview looking southeast, showing west and north elevations. Note vinyl covering on building including the exterior chimney.

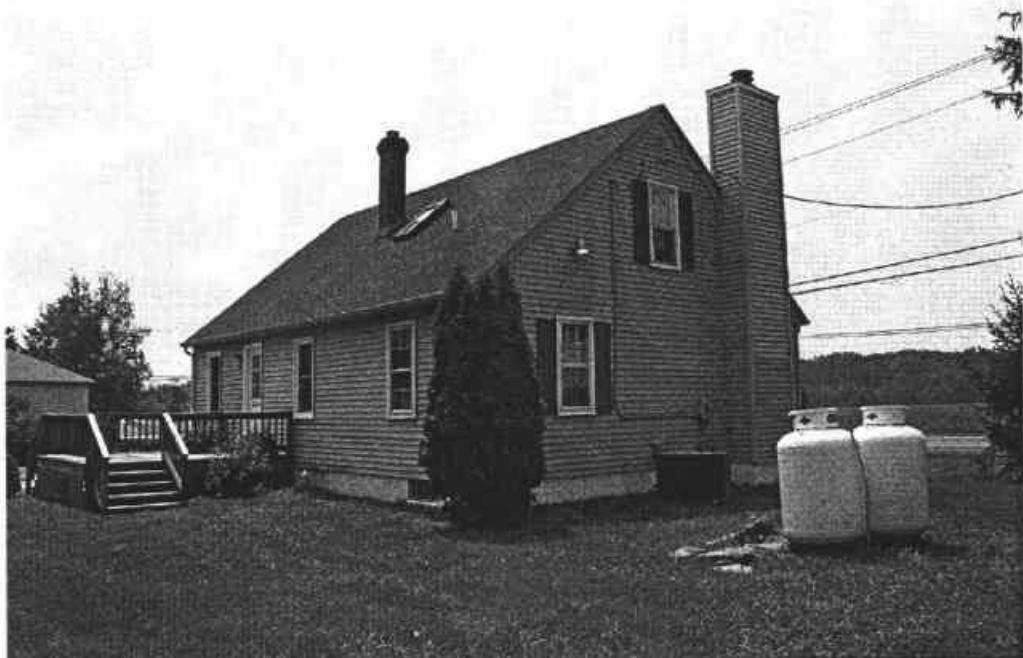
N14386. Photograph 2. 4847 Summit Bridge Road, east and north elevations, view looking southwest. Note modern deck.

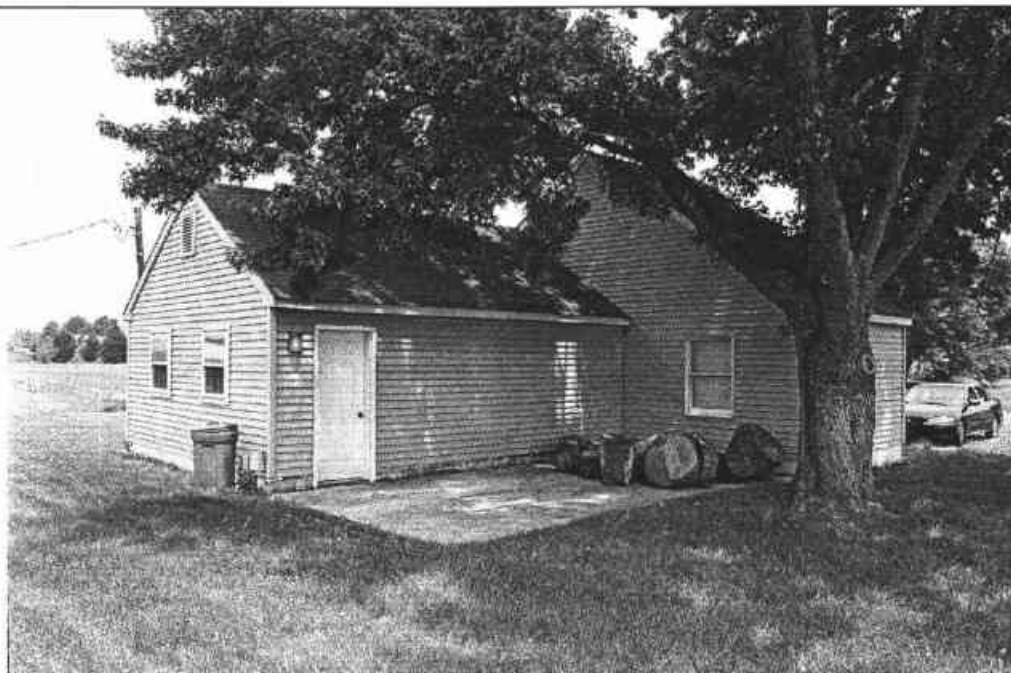
N14386. Photograph 4. Garage, west and south elevations, view looking northeast. Note the one-and-one-half story addition extending from the one-story core.

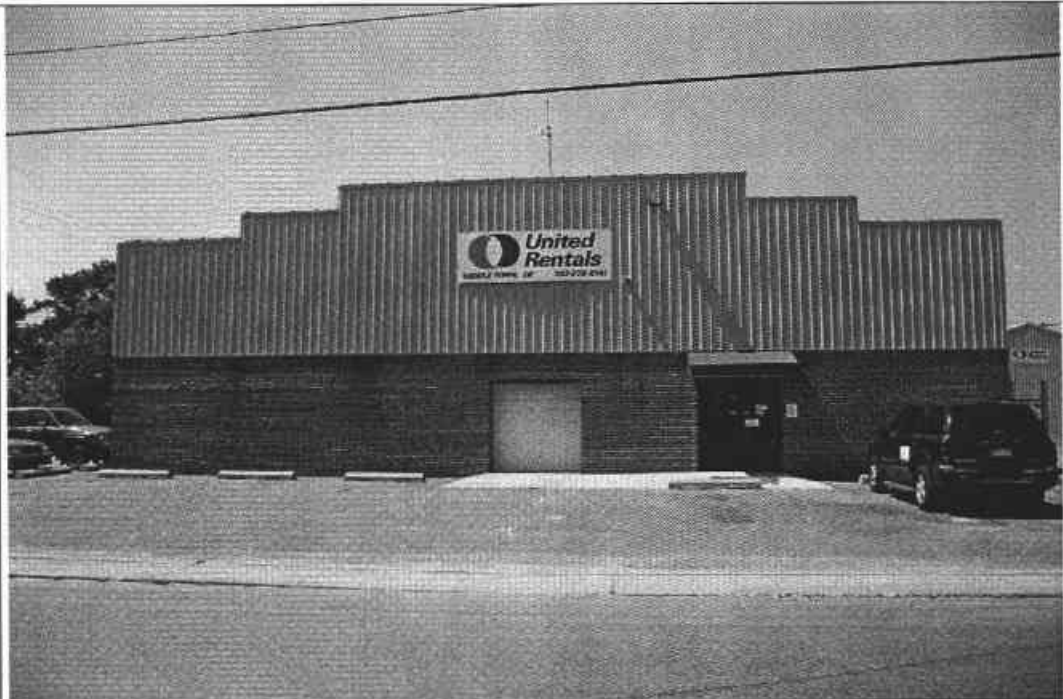
N14387. Photograph 1: Former textile mill, façade (east elevation), view looking west. Note aluminum siding added to upper half of façade and reconstructed fenestration.

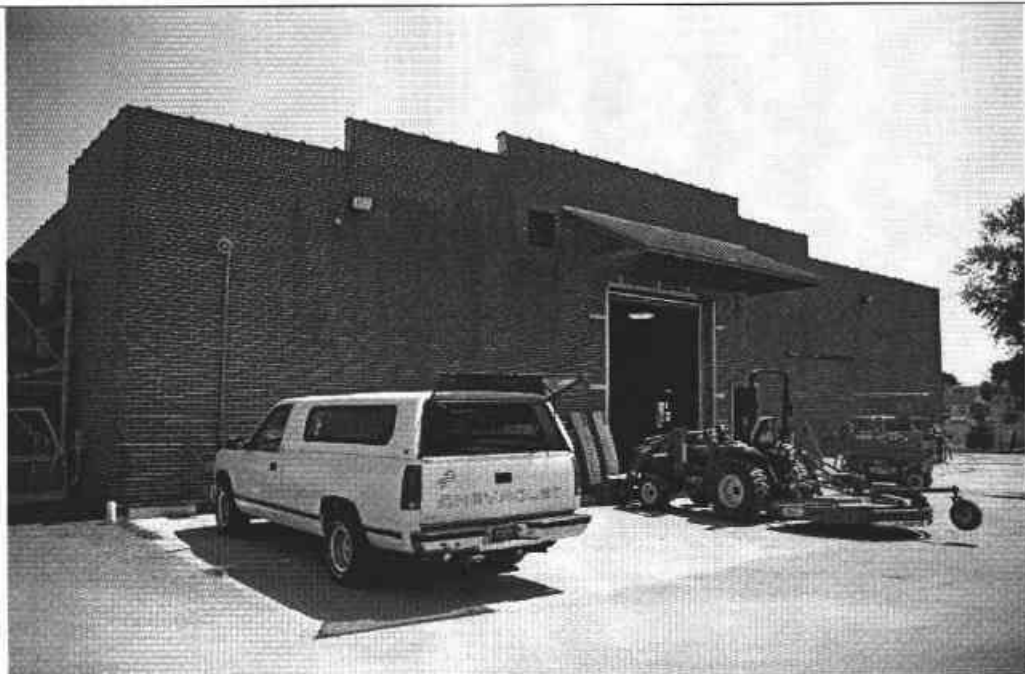
N14387. Photograph 2: Former textile mill, rear (west) elevation, view looking southeast.

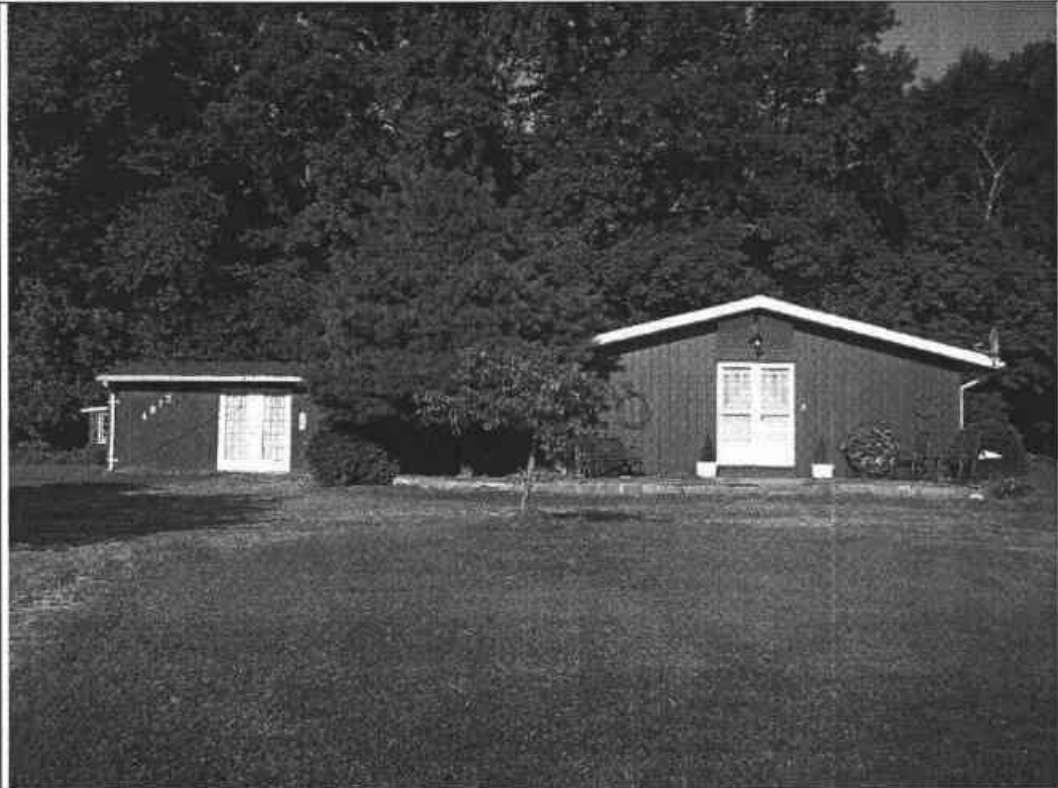
N14395. Photograph 1: Westrod House, view of east elevations looking west. Note the *circa*-1970 side gable addition extending from the south elevation.

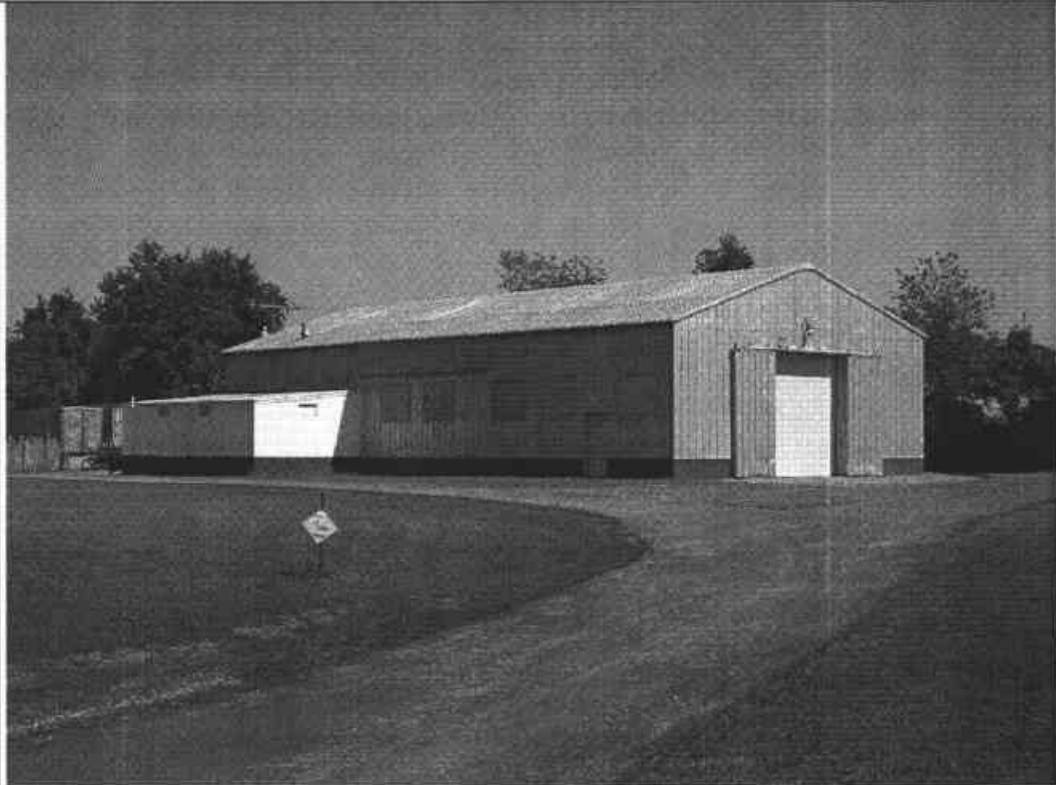
CRS No. N14396

N14396. Photograph 1: Standard Bitrulithic Company, view of south and west elevations, looking east.

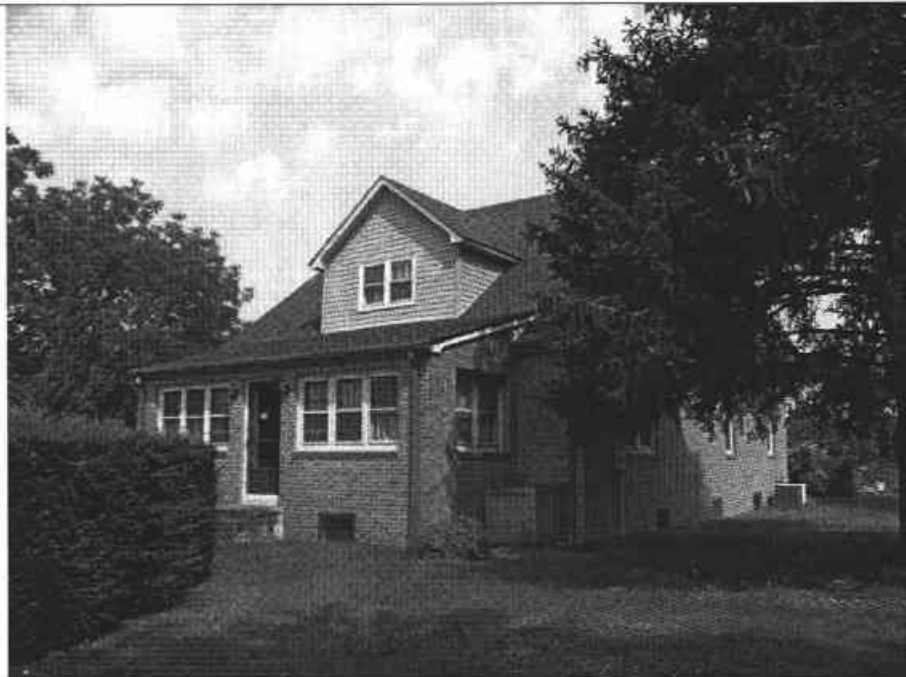
CRS No. N14397

N14397. Photograph 1: Dwelling, south and east elevations, view looking northwest.

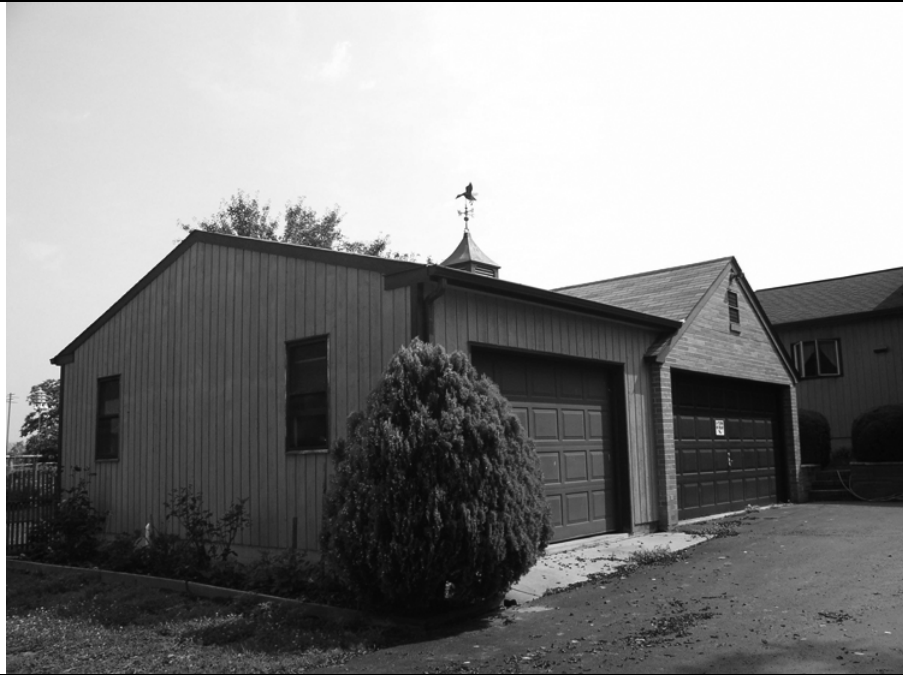
CRS No. N14397

N14397. Photograph 3: Garage, south and west elevations, view looking northeast.
